# Manhole Inspection Summary

Manhole # S09EE2008MH

**Location** Address: **5910 GREENSPRING AVE**

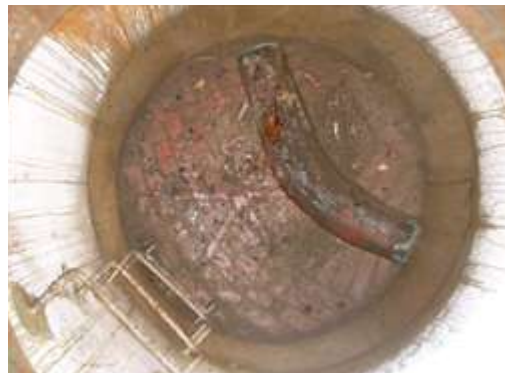
Top View

☒ **Leaks**

Infiltration: ☐ None ☒ **Joint** ☐ Cracks ☐ Mortar ☐ Roots ☐ Wall

**Bench** ☒ Exists Material: **Brick** ☐ Parged ☒ **Debris** (not Condition related)

Bench debris. Infiltration from frame and adjustment

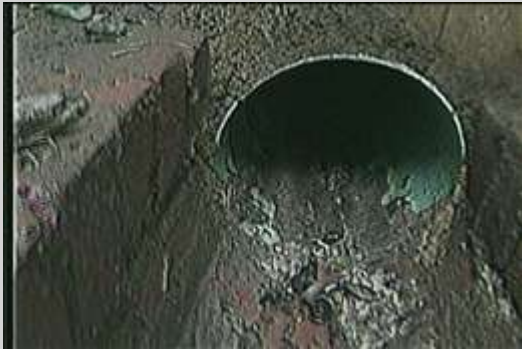
### 8 in. Circular Gravity Sewer Pipe Out @ 12 O'Clock

Deposits: ☐ None ☒ **Mud** ☐ Sludge ☒ **Debris** ☐ Grease

Silt Depth: **0.05** (in.) Deposits Extent: **Light**

Infiltration: **Evidence** Pipe Seal Cond: **Unknown**

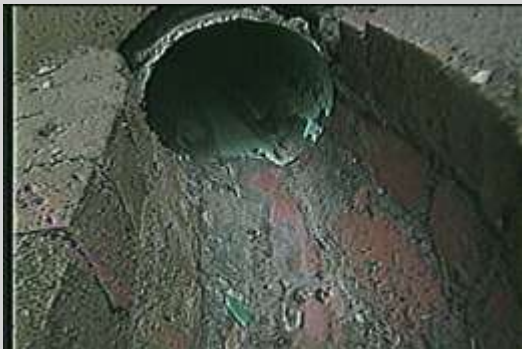
### 8 in. Circular Gravity Sewer Pipe In @ 5 O'Clock

Infiltration: **Evidence** Pipe Seal Cond: **Unknown**
